Subject: Monthly Report of Water Level Measurements from OW-1, OW-2, OAG-21, OAG-22, and TP-173.

Hydrographs forOW-1, OW-2, OAG-21, OAG-22, and TP-173 through August 31, 2012

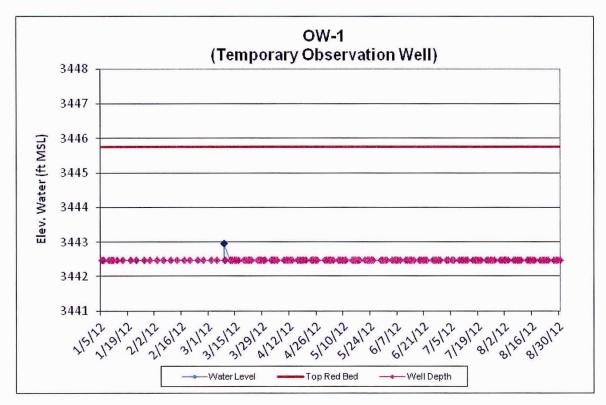
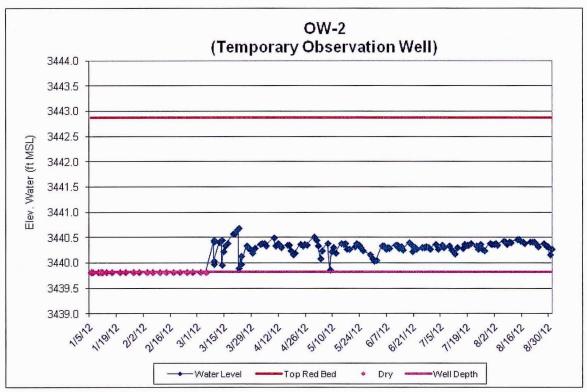
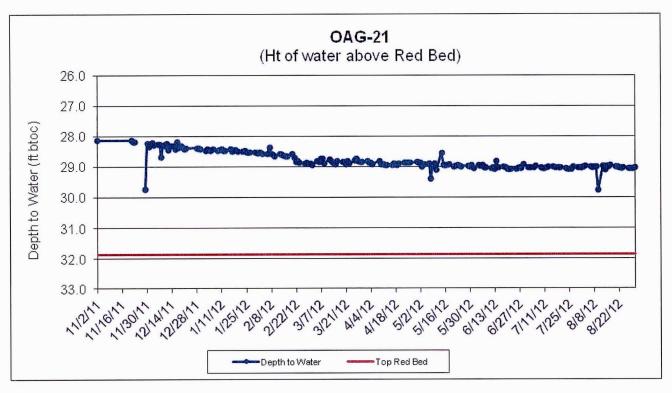
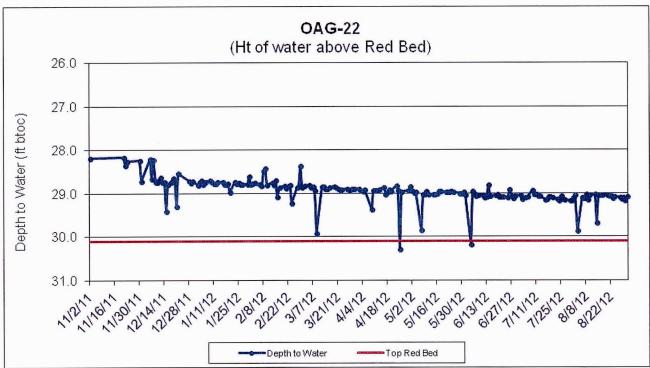
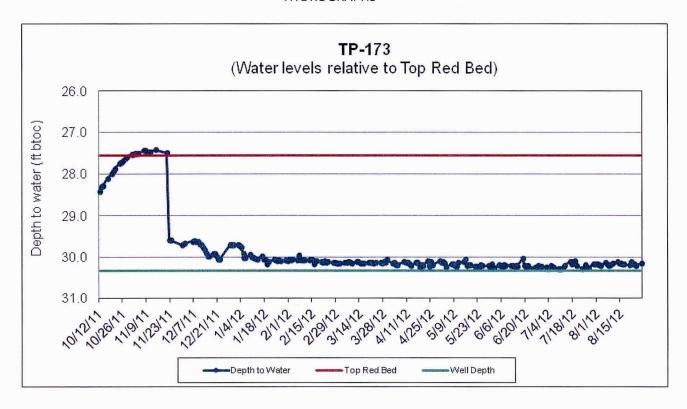
Hydraulic conductivity associated with OAG-21 is sufficient to allow groundwater pumping; while OAG-22 and TP-173 do not recharge at a rate sufficient to provide effective evacuation of water. Hydrographs of water level measurements for wells OW-1, OW-2, OAG-21, OAG-22, and TP-173 are provided in Attachment A. As of August 31, 2012, about 27,900 gallons of water have been removed from OAG-21 since November 2011. For the month of August, the average height of the perched water column above the Dockum/OAG contact has been reduced to slightly more than 2.83 ft and 0.97 ft in OAG-21 and OAG-22, respectively. The OAG unit at TP-173 remains dry. OW-1 and OW-2 have been dry since

their installation in January 2012. As shown on the attached hydrograph, water levels in OW-2 continue to fluctuate but the OAG formation remains unsaturated at that location.
