The NRC and Nuclear Power Plant Safety in 2010

A BRIGHTER SPOTLIGHT NEEDED

DAVID LOCHBAUM

Union of Concerned Scientists
March 2011

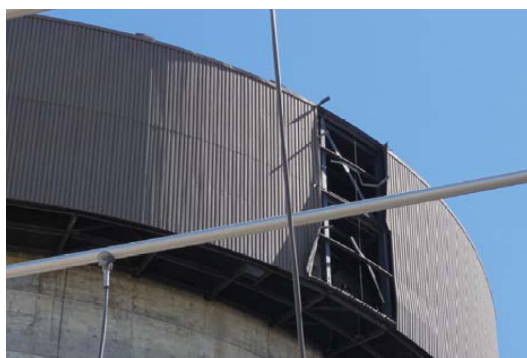
NRC photo of the metal siding torn from the containment building at the Braidwood nuclear power plant in Illinois.

The second violation involved failure to properly evaluate operating experience. Workers had evaluated an event at another nuclear plant where steam had dislodged metal siding, and had concluded that it did not apply to Braidwood. They failed to evaluate a previous event at Braidwood in which steam had dislodged metal siding. The NRC classified both violations as Green—the least serious of the color-coded violations.

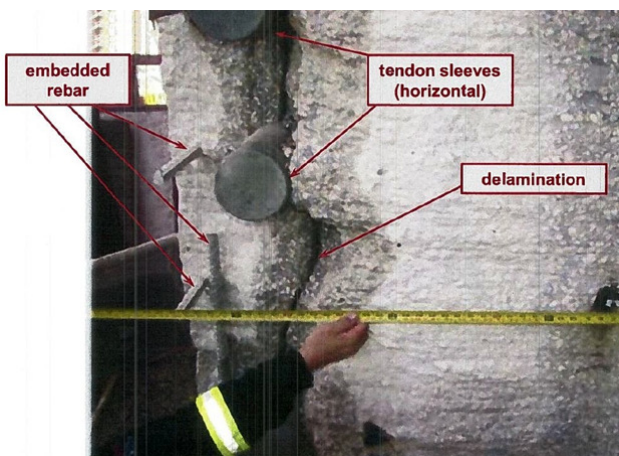
NRC picture of the crack (delamination) in the concrete containment wall at Crystal River 3 caused when workers cut a square opening to replace the steam generators.

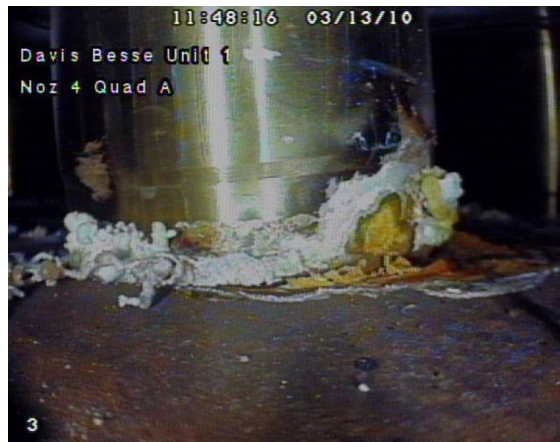
White-crystalline boric acid leaked through a cracked nozzle in the head of the reactor vessel at the Davis-Besse plant in Ohio. NRC photo.

However, inspections during the March 2010 refueling outage revealed that two cracked CRDM nozzles had leaked borated reactor cooling water, and that many other nozzles had apparent cracks. Although the reactor vessel head did not need repair or replacement, workers repaired 24 of the 69 CRDM nozzles.

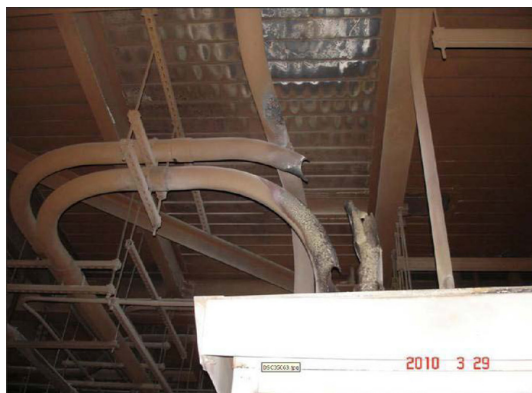
About four hours into the event, the operators attempted to restore power to the de-energized circuit, but they did not check first to ensure that workers had fixed the original fault—and they had not. When the operators closed the electrical breaker to repower the circuit, they reenergized the shorted cable, and it caused another fire. The electrical disturbance also triggered alarms on

Conduit for electrical cables damaged by the fire at the HB Robinson plant. NRC photo.

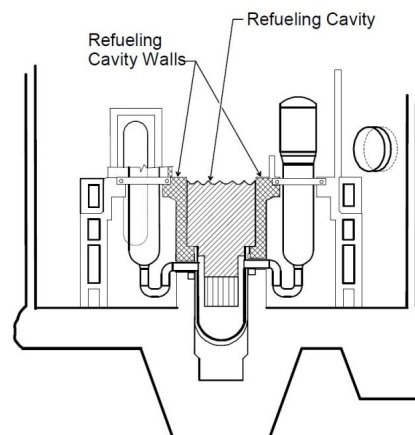
NRC drawing showing refueling cavity walls and the fuel rods located at the bottom of the cross-hatched refueling cavity volume.

However, NRC inspectors at Indian Point recently found that the liner has been leaking 2 to 20 gallons per minute since at least 1993 (NRC 2010v), and that the plant owner has not yet delivered on repeated promises to fix the leak. That means the device installed to prevent leakage after an earthquake is leaking before an earthquake even occurs. The liner has no other safety function. Yet NRC managers have dismissed the longstanding problem, noting that the refueling cavity leaks only when it is filled with water (NRC 2010o).

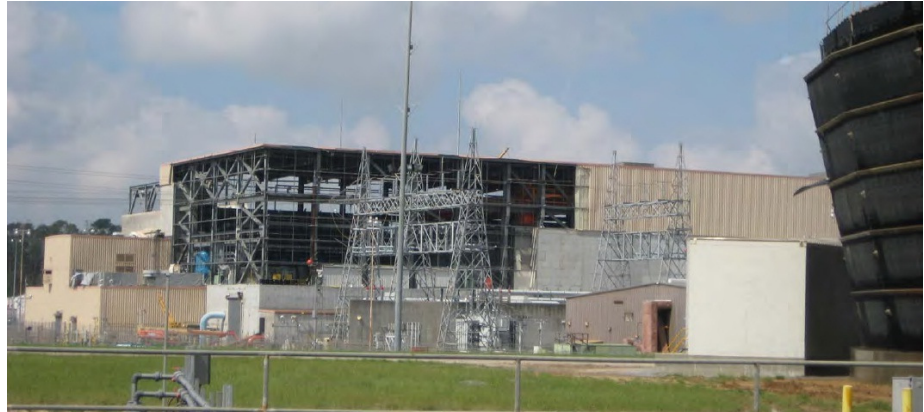
In September 2008, Hurricane Gustav caused considerable damage to the River Bend nuclear plant outside Baton Rouge, La. High winds tore sheet metal siding from three sides of the turbine building. The company repaired some damage and prepared to restart the reactor—planning to replace the walls of the turbine building later.

The turbine building at the River Bend plant after Hurricane Gustav removed its metal siding. NRC photo.
