**WASTE CONTROL
SPECIALISTS LLC**

March 28, 2012

Subject: **Observations at OW-1 and OW-2 and Progress at OAG-21**

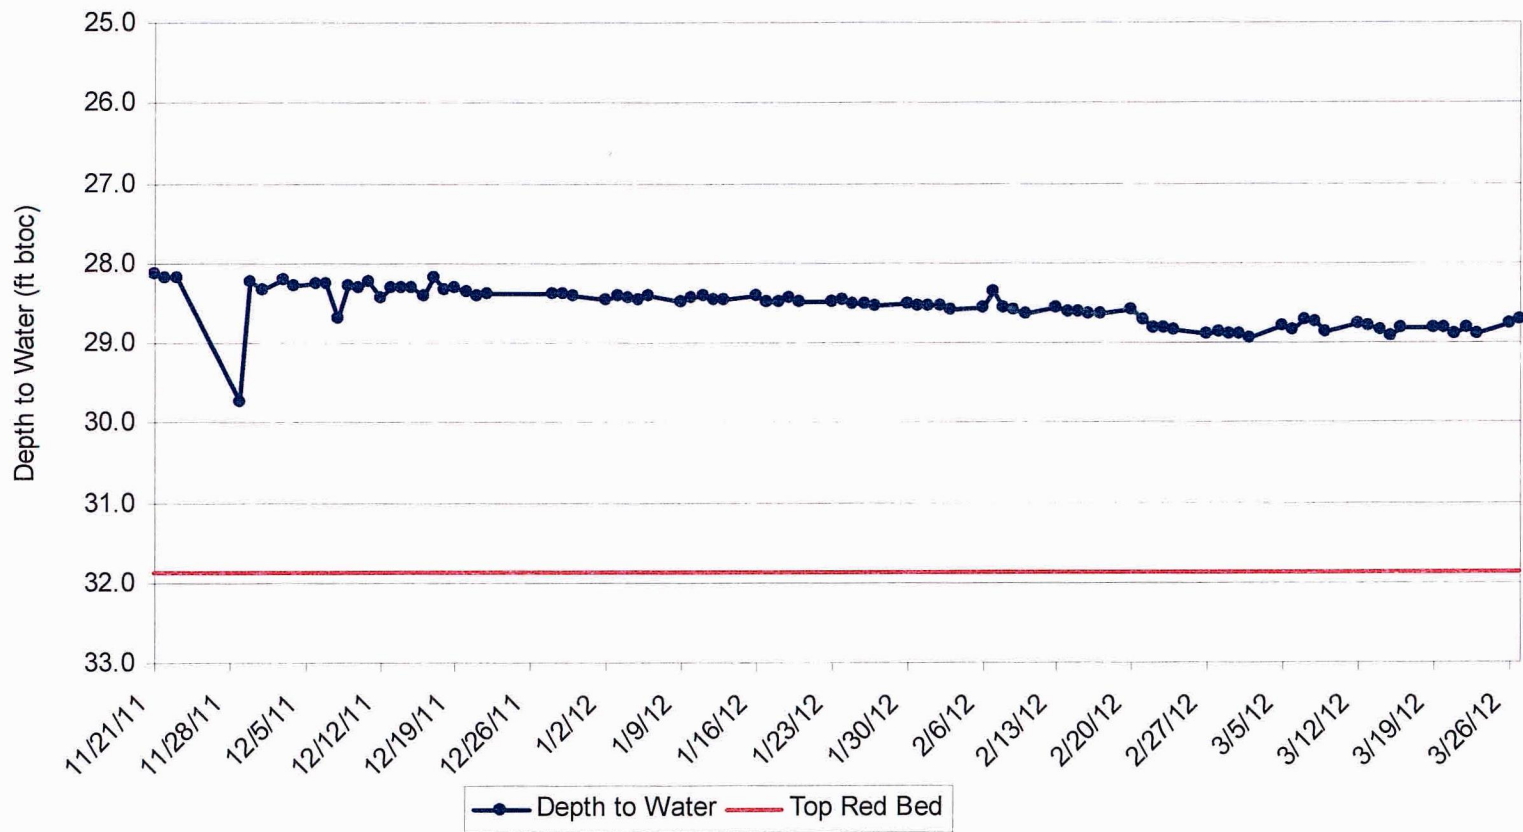
Water levels in OAG-21 continue to slowly decline. Between the end of November 2011 and the end of March 2012 approximately 23,250 gallons of water have been removed from OAG-21. Water levels in the previous playa have dropped about 0.78 ft in four (4) months of

pumping. However, there is about 3.15 ft of groundwater remaining above the OAG/Dockum contact. As shown in the attached graph, the decline appears linear and, if the rate of decline remains the same, it will take around 18 months to reduce the water level to the elevation of the OAG/Dockum contact. At that point, the OAG will no longer be saturated in the vicinity of OAG-21. However, to fully evacuate the groundwater from the previous playa, an additional 18 months (at similar pumping rates and rate of groundwater decline) will be required.

(Ht of water above Red Bed)
